Lake Waynoka Bathymetric Mapping Summary

May 17, 2011

Subject: Lake Waynoka Bathymetric Mapping Summary

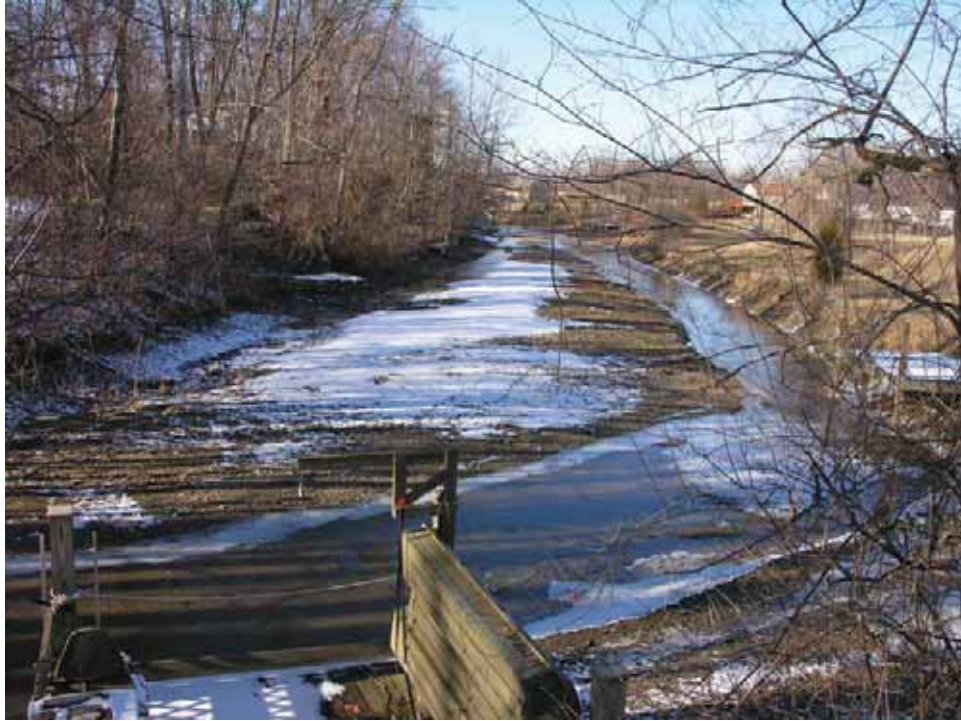
Photograph 1. View from the east end of Straight Creek looking toward the lake. Note the sediment buildup (exposed sand/silt bar) on inside bend (left side) of Straight Creek.

It is important to note that although the water depths measured in some of the coves did not significantly differ from the original water depths, they are very shallow and are likely to become even more shallow if subjected to high sediment loading from upstream. In the cove fed by Straight Creek, we measured minimum water depths of 1.9 feet, which translates to an elevation of 992.58 ft AMSL. This elevation is actually slightly lower than what we were able to interpret from the 1961 topo map, possibly as the result of past dredging. In addition, while recording water depths from the pontoon boat, we stayed primarily within the deepest portion of the channel, meaning that areas outside this main flow path may be shallower than 1.9 feet. The difference in elevations for the erosional outside bend and depositional inside bend of Straight Creek at the eastern-most end of Lake Waynoka is visible in the attached photographs taken in February 2011.

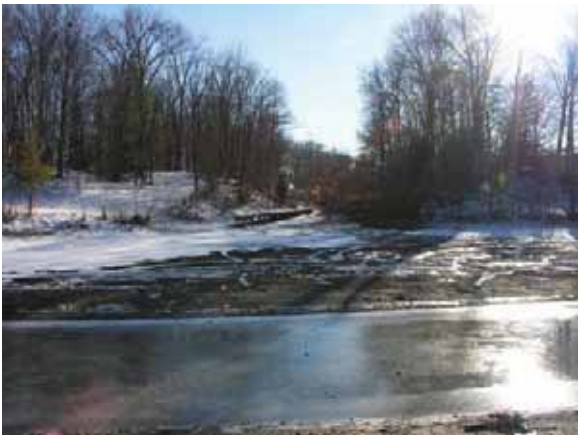
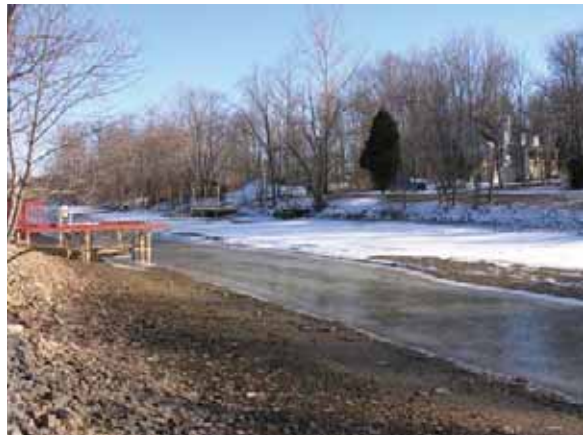
Photographs 2 and 3. Views of the Straight Creek channel looking toward Hiawatha (left) and looking upstream (right).

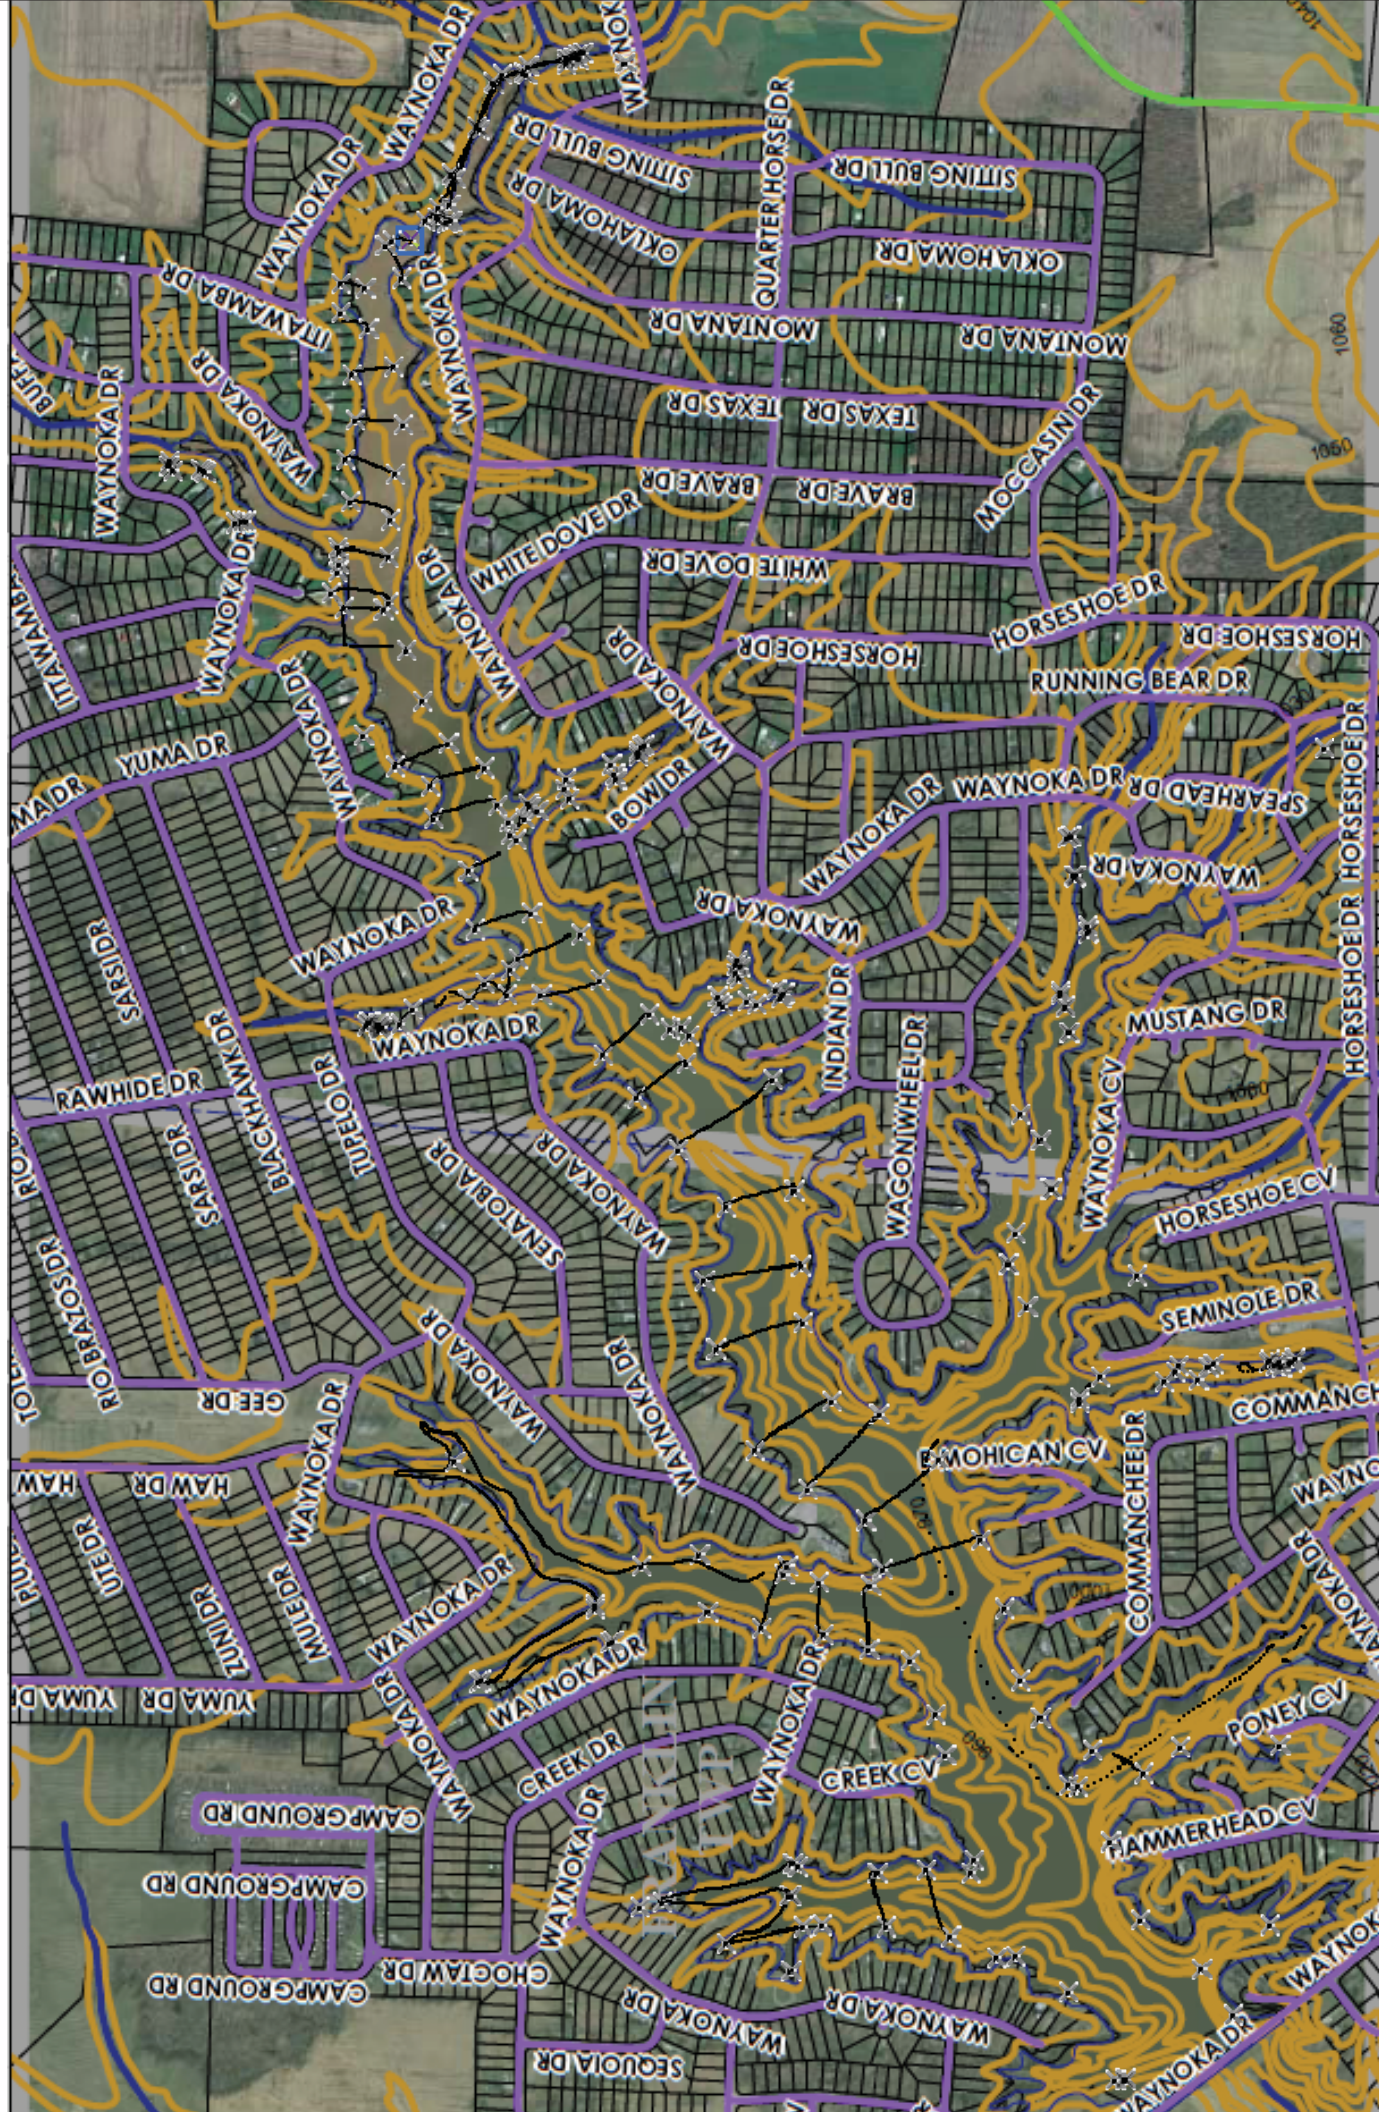
Figure 1. The locations of each transect traveled by the RiverSurveyor is shown on this aerial which is overlain with the 1961 topographic map. The black lines indicate the transect and x's indicate the starting and stopping locations. This aerial with the topographic overlay can be obtained from the Brown County GIS website.

Over a three-day period in April (11-13), we collected water depths from within the lake using a combination of a highly accurate Acoustic Doppler Profiler (ADP) system known as the RiverSurveyor and a hand-held depth sonde. The RiverSurveyor was attached to the side of a pontoon boat and used to measure water depths in the main body of the lake and the larger coves. Transects were sampled from bank to bank and were spaced roughly 250 feet apart. A total of 40 transects were measured across the main body of the lake and another 35 in the large coves. The depth sonde was used to measure water depths in areas that were too narrow for the pontoon boat to easily maneuver. Multiple measurements were collected with the depth sonde in each cove. Figure 1 depicts the transect and supplemental depth measurement locations superimposed on a topographic map available on the Brown County GIS website.
